SAMSUNG ELECTRONICS

SERVICE BULLETIN

Product :	DVDP	Bulletin No. :	98-DVD-E0001
Model :	DVD905	Bulletin Date :	MAR.23.1998
Buyer :	SEA	ECN # & Date :	MAR.23.1998

SUBJECT : DVD905 SYNC TROUBLE(TXG2548 TV)

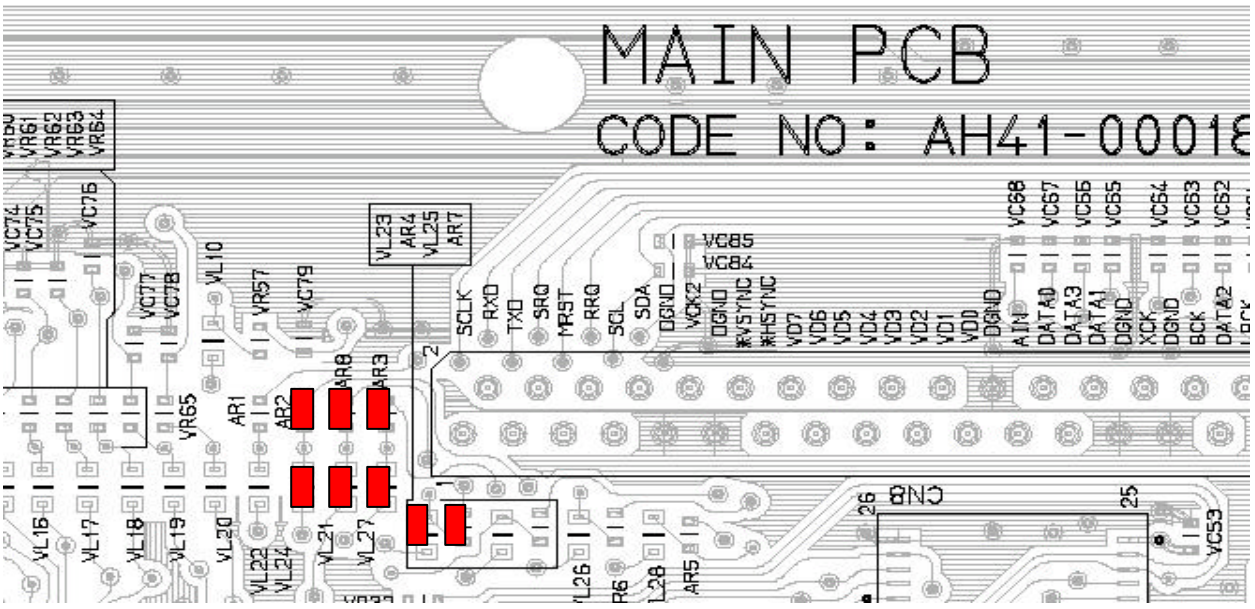
Change:

Background: (Symptom) **Audio signal is absent in Surround outputs.**

Reason: **Some elements are missing**

Solution: **Add missing parts**
